MONTHLY	Q -
MONTHLY	Small Arms PM Tips 36-38
	M2/M2A1 Machine Gun Bushing Gage Not Needed 39
ISSUE 774 MAY 2017	X26E Taser DPM Needed for Storage 39
	Secure Gun Sights to Prevent Loss or Damage 40-41
COMBAT VEHICLES 2	MISSILES 42
M119A3 Howitzer Fire Control Computer PQDR 3 M777A2 Howitzer LRU Turn-ins Needed 4-5	Avenger ECU/PPU W103 Cable Torque 42
M2/M3-Series Bradley M242 Gun Bags and Covers 5	OO coon
M113-Series FOV Glow-plug Engine Conversion Kit 6-7	CBRN 43
DSESTS Assistance 7	CBRN Room Checklist Available 43
Stryker Ramp Hydraulics PM 8 Stryker, No Water in Air Intake 9	
Survivor victor in make	TOOLS 44
TACTICAL VEHICLES 10	
	M7 FRS Operation and Maintenance Tips 44-45
M1165A1, M1152A1 HMMWV Mount Guidance 11	COMMUNICATIONS 46
HMMWV Transmission Filter NSN 12 M1235A4/A5 MaxxPro Dash ISS w/OGPK/CROWS	
Pitman Arm Output Shaft Boot 13	SINCGARS RT-1523G, HUB CCA Replacement 47
M1083A1P2 FMTV Axle Replacement Update 14-15	HMS Manpack Radio, RT-1967(C)U, Low Power Defect Workaround 48

TB 43-PS-774. The Preventive Maintenance Monthly, is an official publication of the Department of the Army, providing information for all Soldiers assigned to combat and combat support units and all

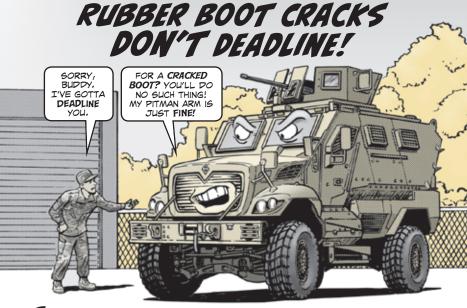
Some units are deadlining the M1235A4/A5 MaxxPro Dash ISS MRAP during checks and services. Why? Because they see cracks in the rubber boot cover on the steering gear output shaft that connects to the pitman arm.

Cracks or tears in the output shaft boot **do not** deadline your vehicle. Cracks there have no bearing on the form, fit or function of the pitman arm. The pitman arm has an internal seal to protect it.

For more info, check out TACOM Maintenance Information message 16-046: https://tulsa.tacom.army.mil/Maintenance/message.cfm?id=MI16-046.html

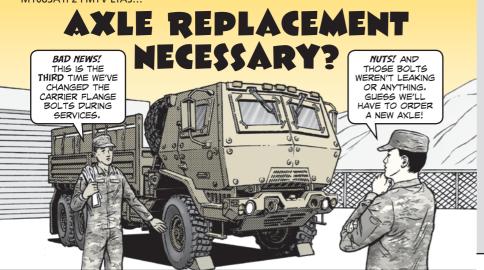
M1083A1P2 FMTV LTAS...

While creating service packets for our mechanics, I noticed that the M1083A1P2's TM 9-2320-333-13&P says to replace the vehicle's carrier flange bolts during semi-annual services. The TM also says to replace the front axle once the bolts have been replaced three times.

Tests have confirmed that the LTAS' additional weight strains the front axle and can, over time, stretch the flange bolts and warp the holes on the axle housing. The replacement instructions were put in place to ensure your safety and the safety of your equipment.

- Check the carrier flange bolt to make sure it's torqued to 74-96 lb-ft.
- Look for any carrier flange leaks.

- Replace all carrier flange bolts. Put some sealing compound, NSN 8030-01-014-5869, on the replacement bolt's threads and torque to 74-96 lb-ft.
- Metal stamp, electro-etch or engrave the date on the axle housing each time the carrier flange bolts are replaced.
- If the carrier flange bolts are replaced three times, then replace the axle.

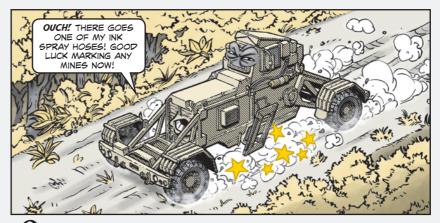
RESTRAIN INK SPRAY HOSES!

HOSES THAT ARE LOOSE OR PANGLING WILL GET RIPPED OFF THE VEHICLE ON THE WAY TO THE WORK SITE, YOU WON'T BE MARKING MANY MINES THEN!

OPERATORS, MAKE SURE THE HUSKY'S INK SPRAY HOSES ARE PROPERLY ROUTED, ATTACHED AND TUCKED AWAY WHENEVER THE VEHICLE'S MINE DETECTOR HEADS ARE IN THE ELEVATED POSITION.

CHECK THE HOSES BEFORE AND AFTER THE DAY'S RUN. NOTIFY YOUR MECHANIC IF ANY OF THE INK LINES ARE LOOSE OR DAMAGED.

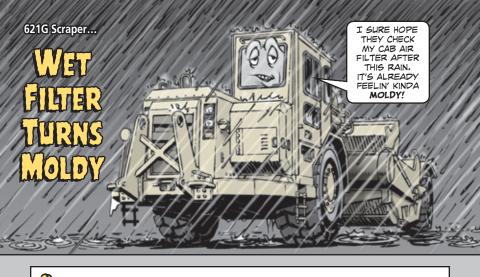
perators, make sure you keep a close eye on the 621G scraper's cab air filter, especially after a heavy rain.

The filter's access door has a series of louvers that allows open air flow. Problem is, the louvers also allow water from rain and cab run-off inside the door. That water fills the channel along the inside bottom of the door.

The hoses are installed with a grommet that fits into a hole in the plastic drip pan. But the grommet doesn't fit tight and leaks.

Replace a wet or moldy filter element with NSN 4310-01-602-0614. Then follow the instructions in TACOM GPA 17-008. It tells how to drill two drain holes in the door channel and add two O-rings, NSN 5331-01-333-6444, to the A/C drip pan grommet. See the message at:

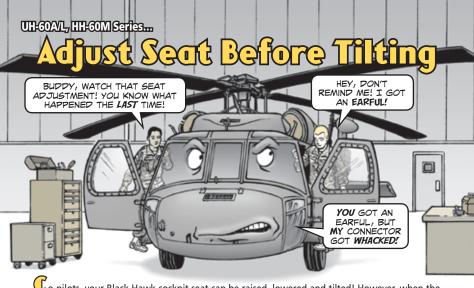
Some have learned the hard way that when you tilt the seat back while it's in its lowest position, the connector for the dome light dimming switch hits the box housing the pilots collective stick. When that happens, it breaks the dome light connector.

The only way to prevent tearing up the connector is to raise the seat up just enough for the headrest to clear the circuit breaker panel above, which provides clearance below for the dimming switch connector, then push the seat back completely. Then when you tilt the seat back to the cabin floor, the connector will clear the box and it won't get damaged.

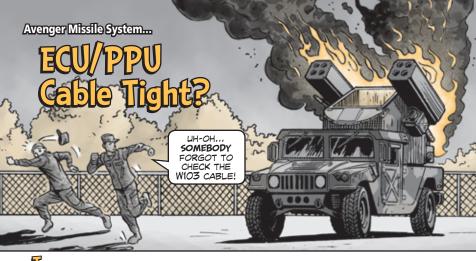
If your Avenger is to get it right, you've got to make sure the W103 cable for the environmental control unit/primary power unit (ECU/PPU) is tight. The W103 has a shielded ground. If the cable is loose, it arcs and starts a fire. The gunner could be cooked in the turret!

Firmly grasp the W103's connector and try to turn it clockwise. If you can move it at all, your repairman needs to tighten it to 95-105 in-lbs. Even if you can't budge the W103, but suspect it might have problems, get your repairman to check it. Don't take chances!

Repairmen, remember that you're supposed to check the W103's torque every 250 hours of operation or semiannually, whichever comes first. This is spelled out in Table 2-1 in TM 9-1440-433-24-1 in IETM EM 0017 (Sep 13).
