AH-64D/E TADS/PNVS: Protection of the TADS Display Unit (TDU and C-TDU)

TADS/PNVS

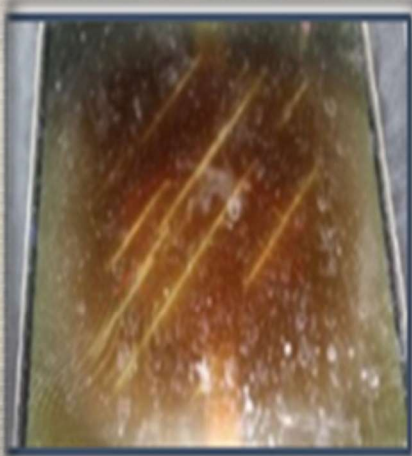
If you are seeing trouble with screen degradation on TADS/PNVS TDU, what you are seeing is a breakdown in the polarization layer of the unit caused by sunlight exposure or solar radiation. The TDU has a polarization filter layer that is prone to degradation when exposed to solar radiation, heat and humidity. The degradation manifests itself as “Scratch Marks” followed by a “Halo” effect. Once this break down begins to occur, it will become progressively worse. The damage increases the absorption of ultraviolet energy therefore increasing the heating effect and loss of transparency. The potential mission impacts are threefold. The first is the polarizer failure reduces targeting display performance before the operator recognizes the degradation. The second is the ranges for detection, recognition, and identification is negatively impacted. The third is a complete failure of the TDU/C-TDU will cause the component to be non-mission capable resulting in significant aircraft mission impact. The problem is so acute that the current scrap rate for TDUs is 65% on all units that are turned in. Protecting the TDU from this type of damage is simple – Use the Cover. Supporting evidence from FMS users show that use of the cover mitigates or eliminates the degradation. The TDU cover (Part# 76502623-001) has been issued with every new aircraft coming off the production line since 2007 and is part of the aircraft flyaway gear. It is also included on the DA form 2408-17 Aircraft Inventory Record. A publication change is occurring on the next update for the Interactive Electronic Technical Manual (IETM) to add the remove/install instructions.

Pictures above: Damaged TDU, TDU cover in cockpit
