MONTHLY	Q -
MONTHLY	Small Arms PM Tips 36-38
	M2/M2A1 Machine Gun Bushing Gage Not Needed 39
ISSUE 774 MAY 2017	X26E Taser DPM Needed for Storage 39
	Secure Gun Sights to Prevent Loss or Damage 40-41
COMBAT VEHICLES 2	MISSILES 42
M119A3 Howitzer Fire Control Computer PQDR 3 M777A2 Howitzer LRU Turn-ins Needed 4-5	Avenger ECU/PPU W103 Cable Torque 42
M2/M3-Series Bradley M242 Gun Bags and Covers 5	OO coon
M113-Series FOV Glow-plug Engine Conversion Kit 6-7	CBRN 43
DSESTS Assistance 7	CBRN Room Checklist Available 43
Stryker Ramp Hydraulics PM 8 Stryker, No Water in Air Intake 9	
Survivor victor in make	TOOLS 44
TACTICAL VEHICLES 10	
	M7 FRS Operation and Maintenance Tips 44-45
M1165A1, M1152A1 HMMWV Mount Guidance 11	COMMUNICATIONS 46
HMMWV Transmission Filter NSN 12 M1235A4/A5 MaxxPro Dash ISS w/OGPK/CROWS	
Pitman Arm Output Shaft Boot 13	SINCGARS RT-1523G, HUB CCA Replacement 47
M1083A1P2 FMTV Axle Replacement Update 14-15	HMS Manpack Radio, RT-1967(C)U, Low Power Defect Workaround 48

TB 43-PS-774. The Preventive Maintenance Monthly, is an official publication of the Department of the Army, providing information for all Soldiers assigned to combat and combat support units and all

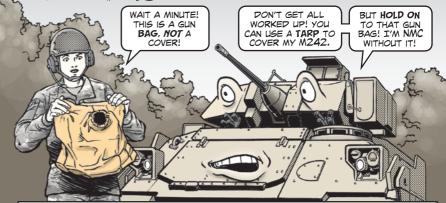
THAT WASN'T AN M242 COVER!

Page 9 in PS 766 (Sep 16) said you could order a cover for your M242 gun with NSN 1005-01-171-8316.

But that brings up an important point: If the Bradley is missing the gun bag, the Bradley is NMC. And gun bags often go missing because crews remove them when the bags get in the way. If the bag's mounting hardware disappears, the components have to be ordered individually, which is a hassle.

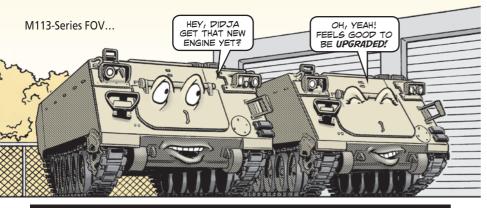
NEW ENGINE CONVERSION KIT!

THE M113-SERIES FOV'S HEATER BOX-EQUIPPED ENGINE, NSN 2815-01-248-7644, IS BEING PHASED OUT THROUGH ATTRITION.

ITS REPLACEMENT IS THE GLOW PLUG-EQUIPPED ENGINE, NSN 2815-01-412-2715.

IF YOU HAVE AN MILT THAT'S DUE FOR AN ENGINE REPLACEMENT, ORDER THE NEW VERSION!

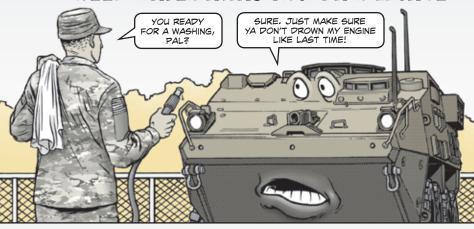
Stryker... REEP WATER AWAY FROM AR INTAKE

WHEN IT'S TIME TO GIVE YOUR STRYKER A GOOD WASHING, MAKE SURE YOU DON'T PROWN THE ENGINE WHILE YOU'RE AT IT!

WHILE AT THE
WASH RACK, YOU
DON'T NEED TO
SPRAY EVERY NOOK
AND CRANNY. THAT'S
ESPECIALLY TRUE
FOR THE
ENGINE AIR INTAKE.

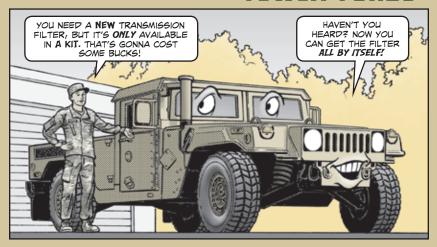
FILTER FOUND FOR FEWER FUNDS

I tried to order a transmission filter, PN 24210468, for one of our M1152A1 HMMWVs. But the PN doesn't cross to an NSN and is only available by ordering a transmission parts kit. The kits, NSNs 2520-01-624-2208 and 2520-01-600-3071, cost $$\pm 350$ and $$\pm 230$ respectively. Either one is a hefty price when only a filter is needed.

After some research, I found that there was a **new** part number available for that filter. PN 24210956 crosses to NSN 4330-01-496-5720, which costs a little under \$11.

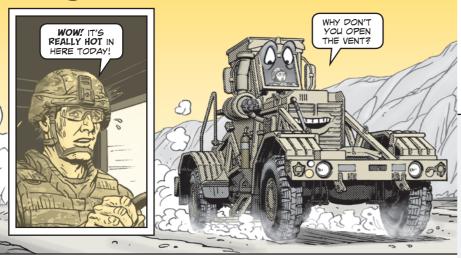
Keepin' It Cool in the Cab

Operators, with the flip of a lever you can let more air into the cab during operations. The lever is right next to your shoulder inside the Husky's cab.

This lever operates a cab air vent. It allows air to flow from outside, through an air filter and into the cab.

Use a 13mm open-end wrench to remove the four bolts that secure the housing in place. Pull out the filter element. If it's dirty, tap it lightly with your hand to loosen dust and sand. If it's very dirty, use low-pressure air (30 psi or less) to clean the filter.

You'll need to clean the filter more often when operating in dusty areas. But never wash the filter with soap and water! That ruins it. Replace a damaged filter with NSN 2945-01-572-7345.

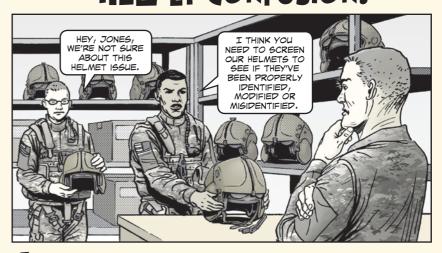
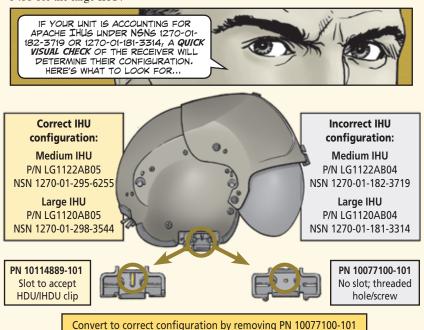
Helmet... ENDING APACHE D MODEL HELMET CONFUSION!

The TACOM headshed recently discovered that years back units had mistakenly identified their medium IHU helmets as NSN 1270-01-182-3719 and large IHU helmets as NSN 1270-01-181-3314. Take a quick look now because you may have a few of these incorrectly labeled helmets.

All medium and large IHUs were field retrofitted between 1989-1990 by MWO 9-1270-200-20-1. The MWO added the then new adjustable mount for the helmet display unit (HDU).

The adjustable mount HDU, which all Apaches currently have, is not compatible with the older IHU configuration because of the style of the HDU receiver assembly. When the MWO was applied, not all maintainers updated the NSNs to reflect the new configuration: NSN 1270-01-295-6255 for the medium IHU and NSN 1270-01-298-3455 for the large IHU.

and installing PN 10114889-101 receiver assembly

Property book officers need to work with their aviation life support equipment (ALSE) folks to screen all unit IHUs. If you find any medium or large IHUs that are misidentified, contact TACOM's James Casto at DSN 786-1359, (586) 282-1359 or by email: james.e.casto.civ@mail.mil
